Oregon Undergraduate Research Journal

6.1 (2014) ISSN: 2160-617X

# Monitoring Riparian Restoration Efforts in the Willamette Valley

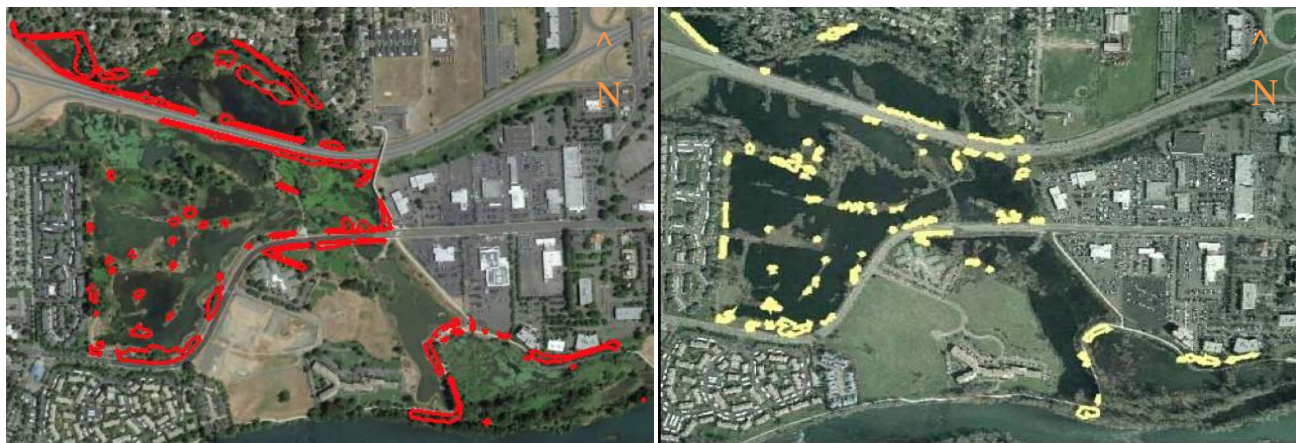
**Figure 3: Upland vegetation community mapping boundaries for 2013 (right) and 2005 (left).**

Completed ground-based mapping delineated each community separately: Upland, Riparian, Wetland Transition, Emergent, Himalayan Blackberry and Restoration in order to display spatial relations throughout Delta Ponds. Those that displayed the greatest change were the Upland, Himalayan Blackberry and restoration communities (Figures 3-5). Based on observations, upland communities were observed as having the largest increase in relation to area surveyed (Figure 2). In contrast, the Himalayan Blackberry communities had decreased, covering 39% of its total former area.

Due to extensive efforts by the City of Eugene, there has been a significant decrease in the proportion of area covered by invasive Himalayan Blackberry since 2005. As of 2013, the largest areas of remaining Himalayan Blackberry were located along the Delta Highway as well as by man-made paths; this coincided with 2005 findings (Figure 4). It should be noted that the Himalayan Blackberry contained within the property of the City of Eugene is substantially lower since part of the surveyed area along Delta Highway included lands owned and managed by Lane County. Because of this, the percent decrease in Himalayan Blackberry on City property is actually much lower. The Upland community displayed the largest relative increase (Figure 2) and often occurred alongside Delta Highway and man-made paths, much like the Himalayan Blackberry community (Figure 3). It is probable that due to reductions in Himalayan Blackberry communities, an increase in the area recognized as Upland resulted from encompassing former Himalayan Blackberry boundaries (Figure 4).

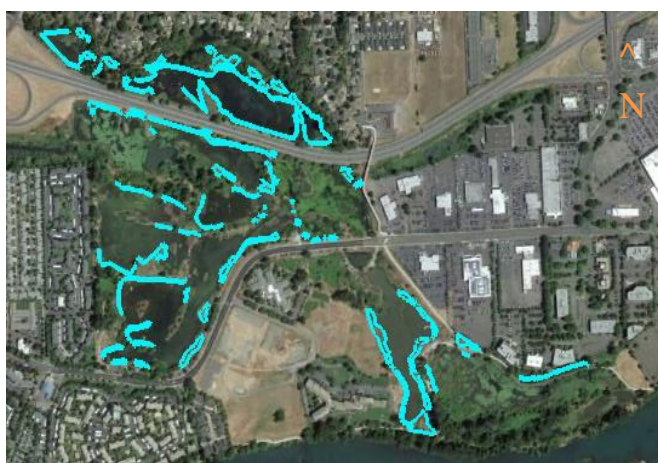
**Figure 5: Recent restoration vegetation community mapping boundaries for 2013.**
